TRANSFORMER & CIRCUIT BREAKER LEAK REPAIR

TRANSMISSION &
DISTRIBUTION
SERVICES

LEAK SEAL SPECIALISTS

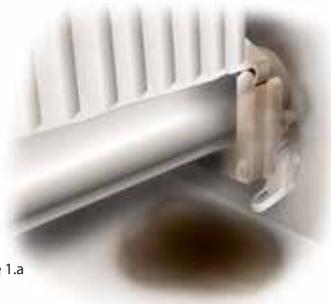
Figure 1.a

An important first-step in repairing transformer oil leaks is leak detection. **Figures 1.a and 1.b** show a 4-bolt flapper valve that is leaking. However, it is difficult to determine what component has failed by visual observation. It could be the flange gasket, the stem, or both areas. TDS personnel thoroughly clean the entire valve assembly and spray on **TDS Oil Leak Detector**. **Figure 2** shows the valve assembly after the oil leak detector has been sprayed onto the suspect components. **Figure 3** shows how the oil has reappeared. Oil has darkened the oil leak detector at the split line between the flanges and around the stem packing area. Therefore, it is apparent that both the flange gasket and stem packing area are leaking. TDS technicians are now able to concentrate their repair efforts on actual leaks.

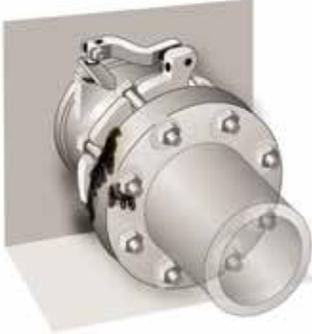
Figure 1

Many larger transformers have 8-bolt butterfly valves to control the oil flow between the radiator and the main tank. Often there are 8-bolt flanges on the pump assemblies. Gasket fatigue invariably leads to leaks (**Figure 1**). Like 4-bolt flapper valve failure, to repair the 8-bolt flange gasket, normally the radiator bank must be drained and the bank removed and all gaskets replaced on the connecting flanges and valves. Since 8-bolt butterfly valves are

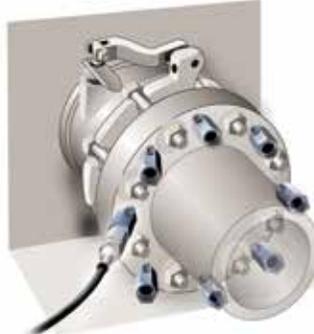
Figure 2

the sealant is tracking in the groove.) Injection valves are threaded into the holes. Sealant is then pumped into the failed gasket area using low-pressure hydraulic techniques (**Figure 2**). The sealant flows into all the failed areas, which thereby stops the leak. Pipe plugs are threaded in the tapped holes after the sealant has cured (**Figure 3**). Usually an 8-bolt flange can be repaired in three hours.

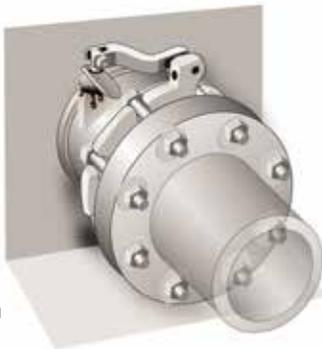
Figure 1

A common transformer leak is the failed packing on 4-bolt flapper and 8-bolt butterfly valve stems (**Figure 1**). Once the packing deteriorates, compression cannot be sustained by continuing to tighten the packing nut so leaks develop. To repair the packing traditionally, the old packing has to be replaced. Since the valve stem is usually on the transformer

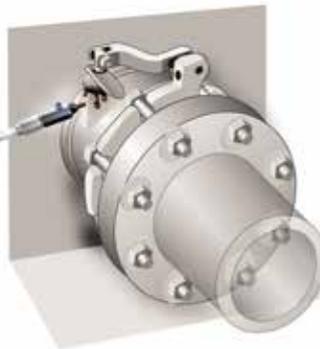
Figure 2

side of the valve, care must be taken not to spill oil during the repair process. This entails draining the oil from the main tank or pulling a vacuum; both are time consuming and expensive procedures. TDS drills and taps a hole into the failed packing area allowing for the temporary installation of an injection valve (**Figure 2**). TDS sealant is then injected

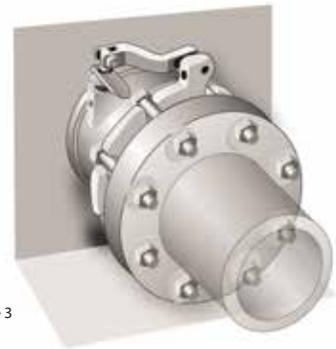
Figure 3

into the packing area with a hydraulic gun. The sealant flows into the packing area until the void is filled and the leak is stopped. TDS sealant is nonadhering and rubber based, which makes it malleable and oil resistant. The valve is fully operational after the repair is complete (**Figure 3**).

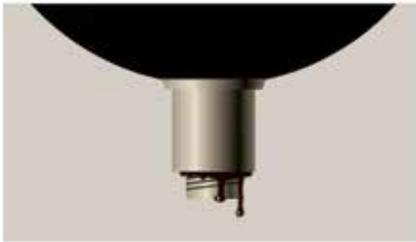
Figure 1

Drain plugs are found at numerous locations on a transformer. The most common location is on the bottom of radiator headers. If additional tightening does not stop these common thread leaks (**Figure 1**), the plug has to be removed and repaired. This entails draining the oil from the radiator bank or compartment. Again, this results in oil processing and downtime for the transformer.

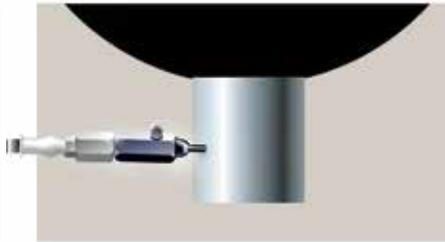
Figure 2

The repair procedure that TDS uses is to enclose the leaking plug with a specially-designed aluminum enclosure (**Figure 2**). TDS technicians inventory various sized enclosures to fit the most common drain plugs. The enclosure is held in place by two set screws and crunch teeth that are located on the inside diameter of the enclosure's bore. Once installed, the enclosure's void is pumped with TDS rubber-based nonadhering sealant which

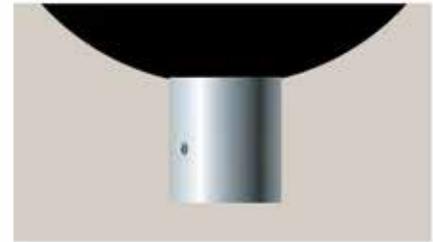
Figure 3

stops the leak (**Figure 3**). As long as the customer wants the leak stopped, the enclosure remains in place. If the customer wants to access the plug, the enclosure can be easily removed. The set screws are loosened and the enclosure tapped off with a rubber mallet. A mold of sealant will be left that can be removed quickly with a razor knife since the sealant is nonadhering.

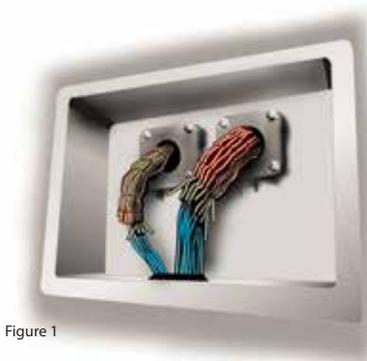
Figure 1

The two junction blocks in **Figure 1** are leaking between the J-Block and the compartment wall. In order to repair these leaks, TDS technicians will take precise measurements of the J-Block area in order to design two clamps that will fully enclose the leak. The clamp seen in **Figure 2** is a two-piece PVC design. Built into the clamp are two grooves for gaskets. The first gasket will seal against the compartment wall.

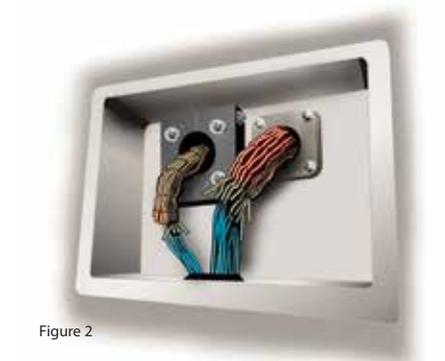
Figure 2

The second gasket will seal just outside the wire bundle diameter on the block itself. To install the clamp it is necessary to use stud extenders on the block's four existing studs. Once the two pieces of the clamp are installed over the stud extenders, two cross bolts and nuts are tightened to bring the two pieces together. The nuts are then tightened on the stud extensions seating both gaskets. The clamp is then pumped with

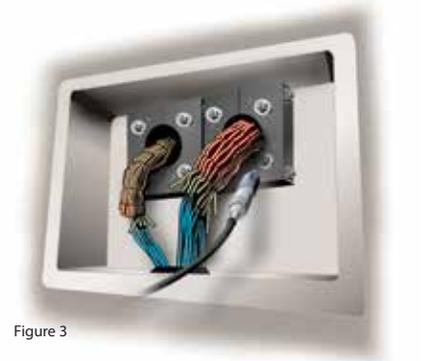
Figure 3

TDS nonadhering sealant (**Figure 3**) and repairs the leak. An outage is required for this repair. Since a traditional repair would necessitate draining the oil from the main tank, the TDS method results in great savings for the utility. Both clamps can be removed easily, if necessary, by unbolting and cutting away the nonadhering sealant. The normal repair time for this procedure is six to eight hours.

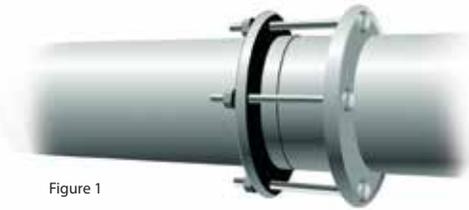
Figure 1

Dresser coupling pipe connections (**Figure 1**) are found on many large transformers. If additional tightening does not fix the leak, oil must be drained from the system in order to replace the worn gaskets. The repair method TDS uses does not require any draining of oil, and the repair can be made while the

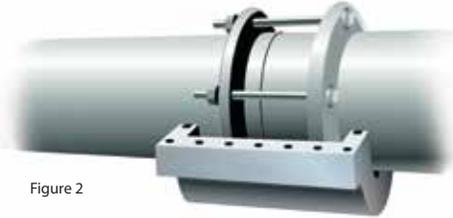
Figure 2

transformer is energized. TDS has standard clamp designs for the typical Dresser couplings found on transformers. The two-piece clamp is fitted around the Dresser and bolted together (**Figure 2**). Note the two gasket seals on the inside diameter of the clamp. These gaskets fit securely around the

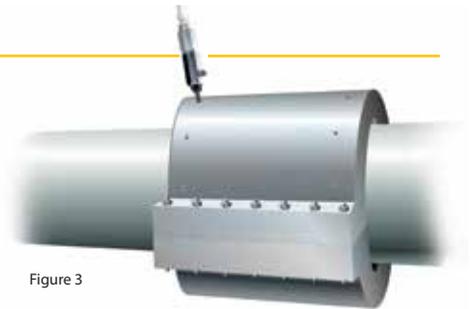
Figure 3

diameter of the pipe to prevent sealant leakage during injection. **Figure 3** shows the clamp being injected with sealant, which repairs the leak. The clamp remains in place after the repair is completed. Estimated time for this repair is four to eight hours.

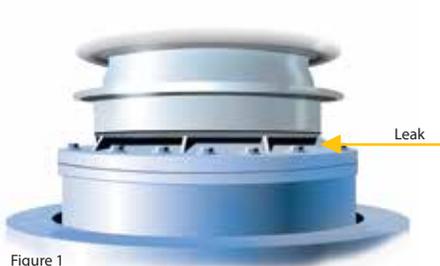
Figure 1

SF 6 gas is expensive and has been designated a "greenhouse" gas by the EPA. Therefore, it is important for electrical utilities to control SF 6 leaks. The traditional repair for a bushing gasket failure is to disassemble the bushing and replace the gasket. Unfortunately, this is an expensive method since the circuit breaker is not operational while the repair is being made. The disassembly and reassembly costs also add to the expense. TDS uses an extremely cost-effective method for repairing these leaks. In **Figure 1**, a SF 6 gas leak has been detected at the gasket that seals the porcelain to flange connection. This leak can be detected by using one of the following methods: an infrared

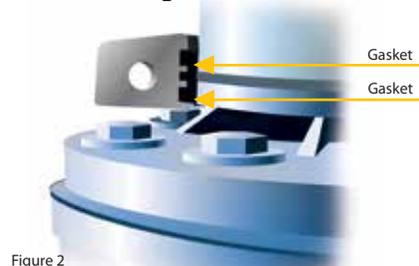
Figure 2

laser device, ultrasonic detection, a gas leak halogen meter, or a common soap solution. TDS technicians take precise measurements of the porcelain and flange outside diameters as well as vertical distances around the leaking area. These measurements are used to design either an aluminum or PVC two-piece clamp that will enclose the leaking area. **Figure 2** shows a profile of half the clamp installed. Note the rubber gasket seals at the top and bottom of leaking area. These gaskets fit tightly against the bushing and the flange in order to isolate the leak and to prevent sealant leakage during sealant injection. The central channel adjacent to the leaking area is where the sealant will be injected.

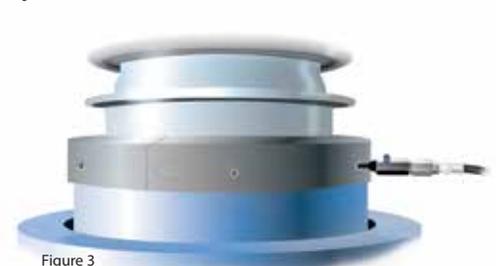
Figure 3 shows the clamp fully installed and sealant being injected into the clamp. TDS uses a rubber-based nonadhering sealant that typically cures in 20 minutes at 70 degrees F. After the sealant cures, the leak is repaired. The clamp stays in place for as long as the utility wants the leak stopped. If for some reason the bushing requires disassembly, the clamp can be removed easily by unbolting it and cutting away the sealant. No damage is done to the circuit breaker in contrast to epoxy repairs. This method drastically reduces circuit breaker downtime, and the cost savings are significant since no disassembly and reassembly are required. This repair can be accomplished in approximately four hours.

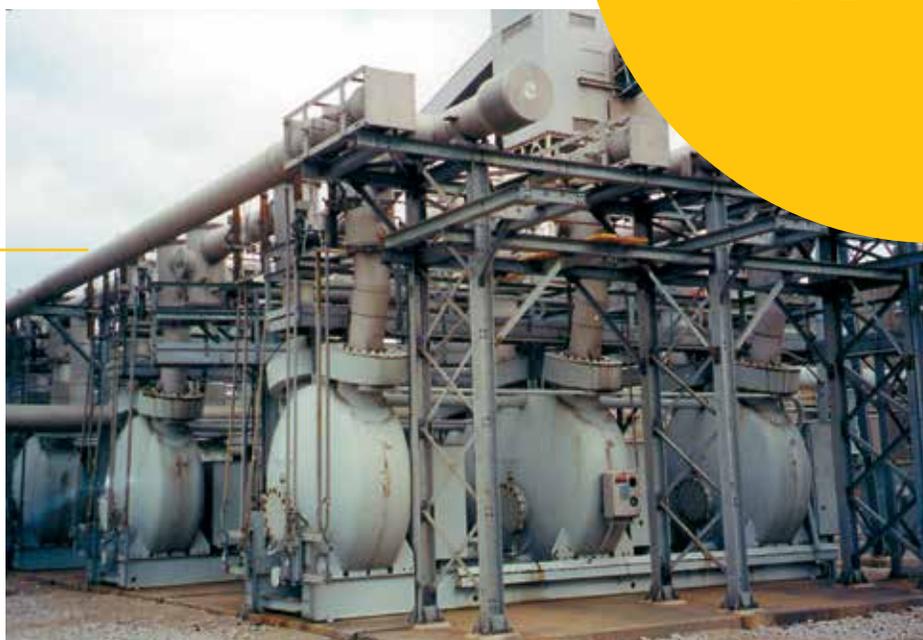
TDS-installed clamp on a Gas Insulated Substation.
